Wood Buffalo Environmental Association  
**Ambient Air Monitoring Station  
Site Documentation**

Athabasca Valley

LAST UPDATED: MARCH 27, 2024

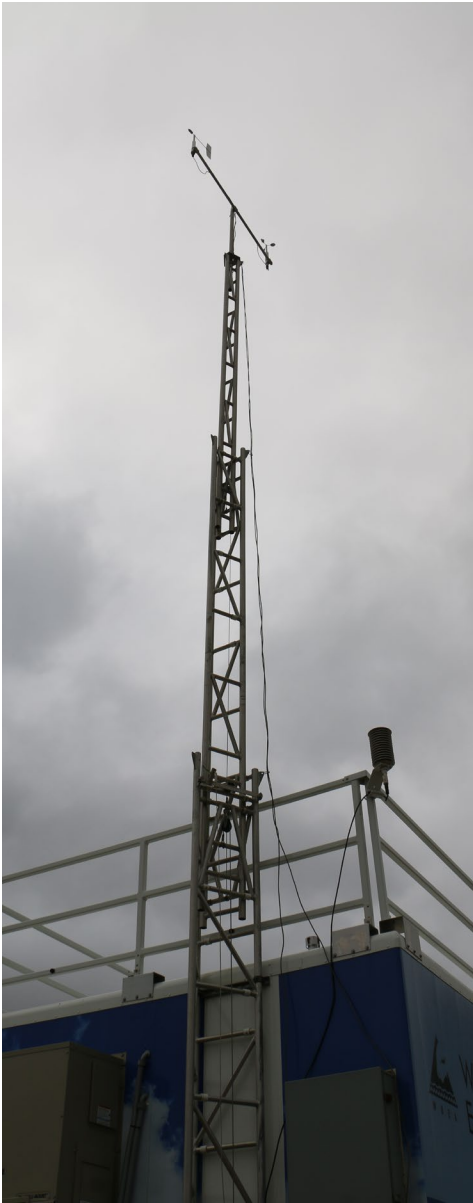
Figure 9 – Meteorological Tower

East	None
	South	None
	West	House
Sample manifold	Type	All glass
	Inlet height above roof	1 metre
Wind Sensors	Type	Cup and vane
	Height above ground (m)	10 m
	Distance from station (m)	Attached to North end of monitoring station

Parameter	Make	Model	Serial Number	WMO Site Class	Date Sensor Installed	WBEA Data Start Date
AT/RH	Vaisala	HMP155	G0840069	3	2020	January, 1999
WD	Met One	020C-1	G3212	3	2021	January, 1999
WS	Met One	010C-1	R14656	3	2019	January, 1999
BP	Young	61302V-10	BPA4395	3	2016	December, 2012

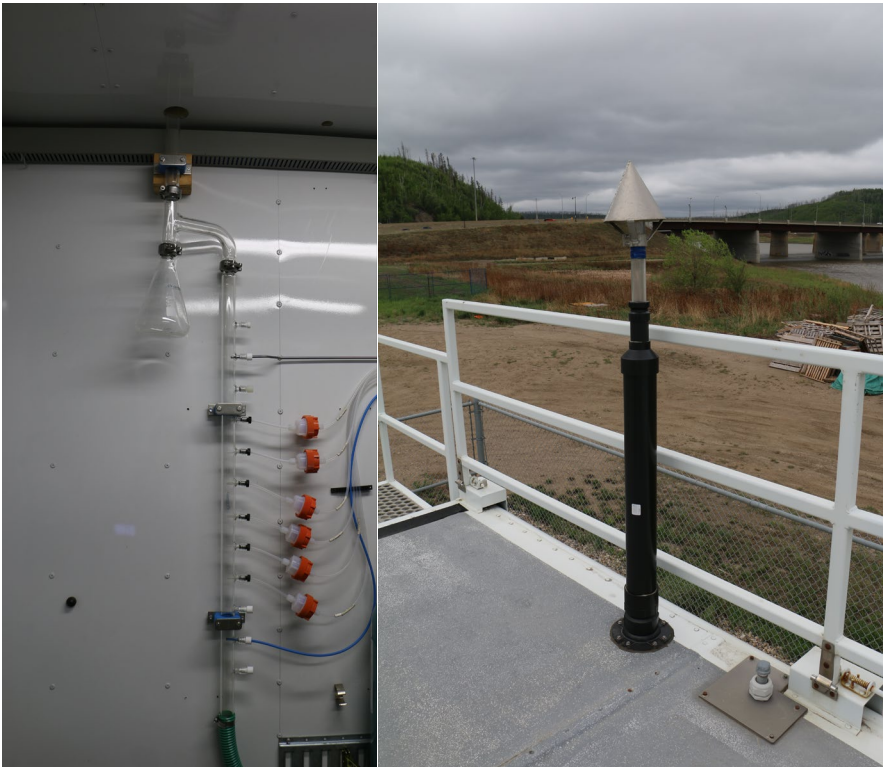
Figure 10 – Photo showing the inlet and sample manifold

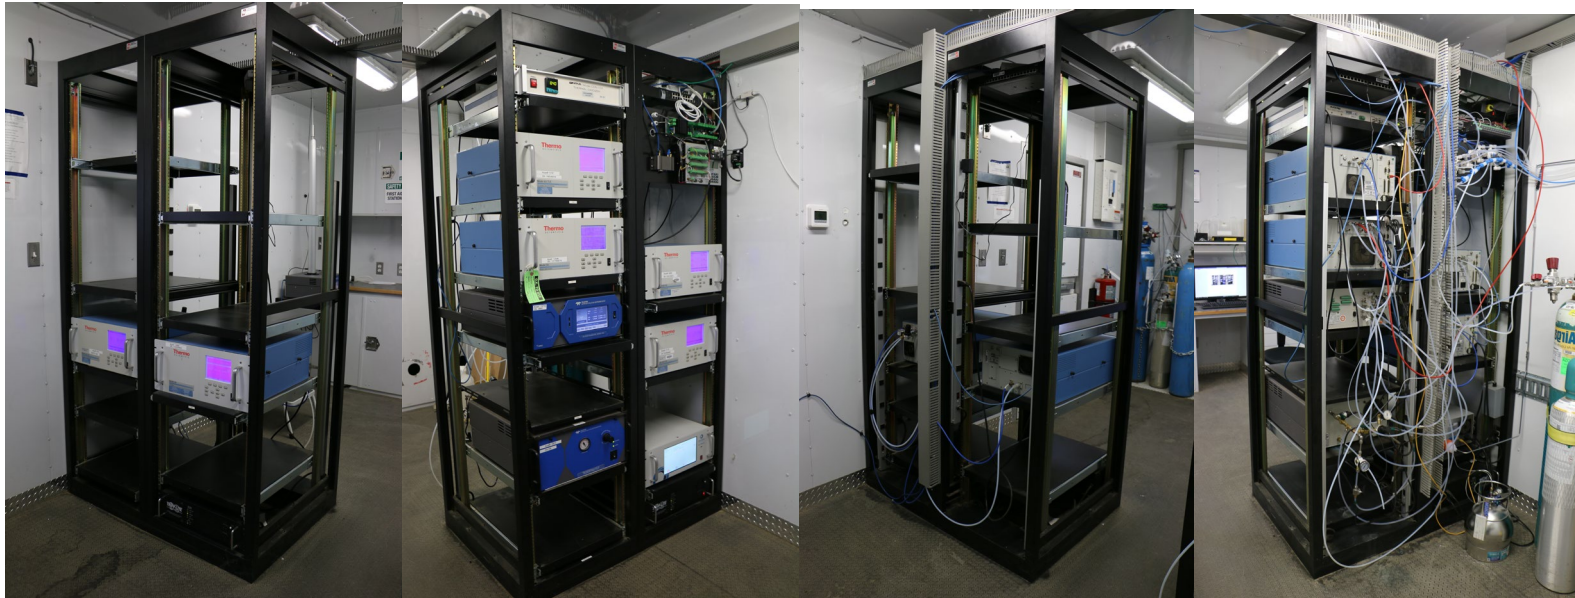
Figure 12 –Photo of the front and the back of instrument rack

Parameter	Make	Model	Serial Number	Date Instrument Installed	WBEA Data Start Date
<b>Continuous</b>					
SO <sub>2</sub>	Thermo Scientific	43i-LTE	1507864683	2020	January, 1999
TRS	Thermo Scientific	43i-LTE	1180540018	2019	January, 1999
TRS conv	CD-Nova	CDN-101	551	2019	-
NO <sub>x</sub> /NO/NO <sub>2</sub>	Thermo Scientific	42i	1160120024	2021	January, 1999
THC/CH <sub>4</sub> /NMHC	Thermo Scientific	55i	12300522720	2024	January, 1999
O <sub>3</sub>	Thermo Scientific	49i	1507964700	2019	January, 1999
CO	Thermo Scientific	48i-LTE	1408761381	2016	January, 1999
PM <sub>2.5</sub>	Teledyne	T640	645	2024	January, 1999
<b>Time-Integrated</b>					
PM <sub>10</sub>	Thermo Scientific	2000i	2000i 0361 1305	2016	-
PM <sub>10</sub>	Thermo Scientific	2000i	2000iW206921702	2021	-
PM <sub>2.5</sub>	Thermo Scientific	2000i	2000i2 0370 1306	2018	-
PM <sub>2.5</sub>	Thermo Scientific	2000i	2000i2 0433 1312	2019	-
PAH	Tisch Environmental	TE-PIF+BL	1001057	2016	-
