Wood Buffalo Environmental Association  
**Ambient Air Monitoring Station  
Site Documentation**

## Lower Camp

LAST UPDATED: MARCH 27, 2024

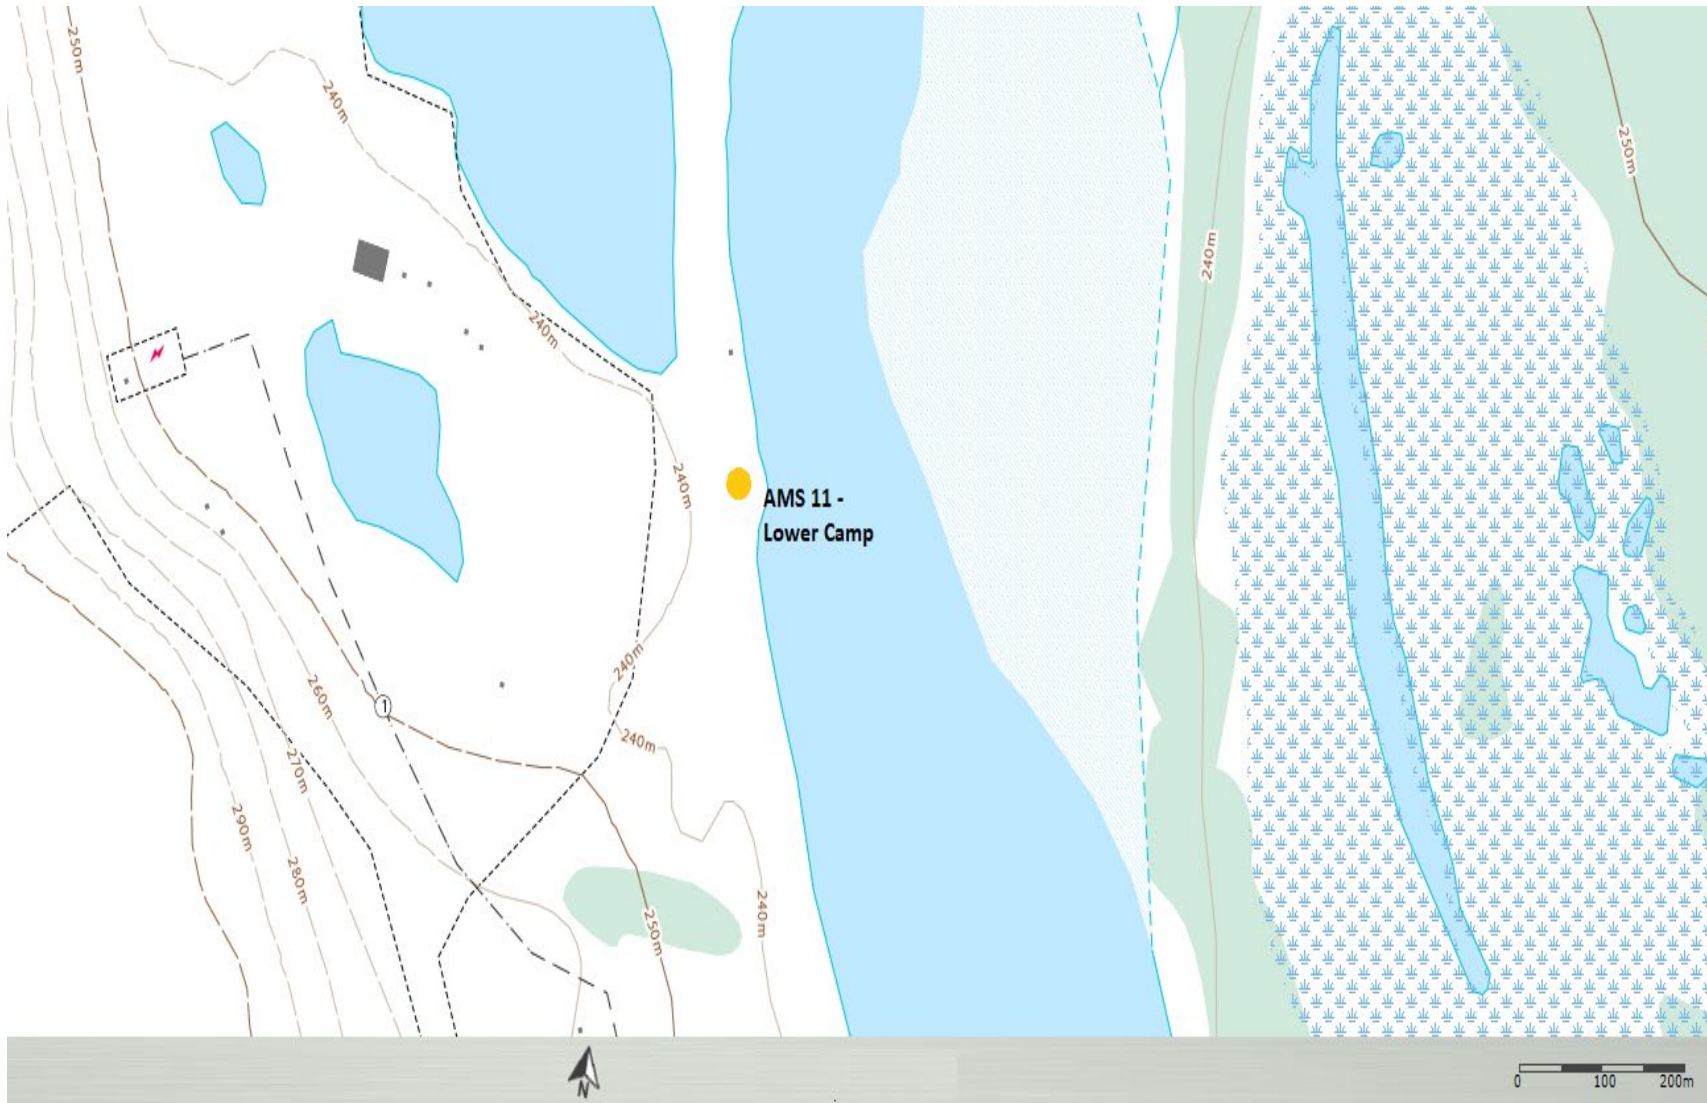
Figure 1 – Area topographic map showing AMS 11.

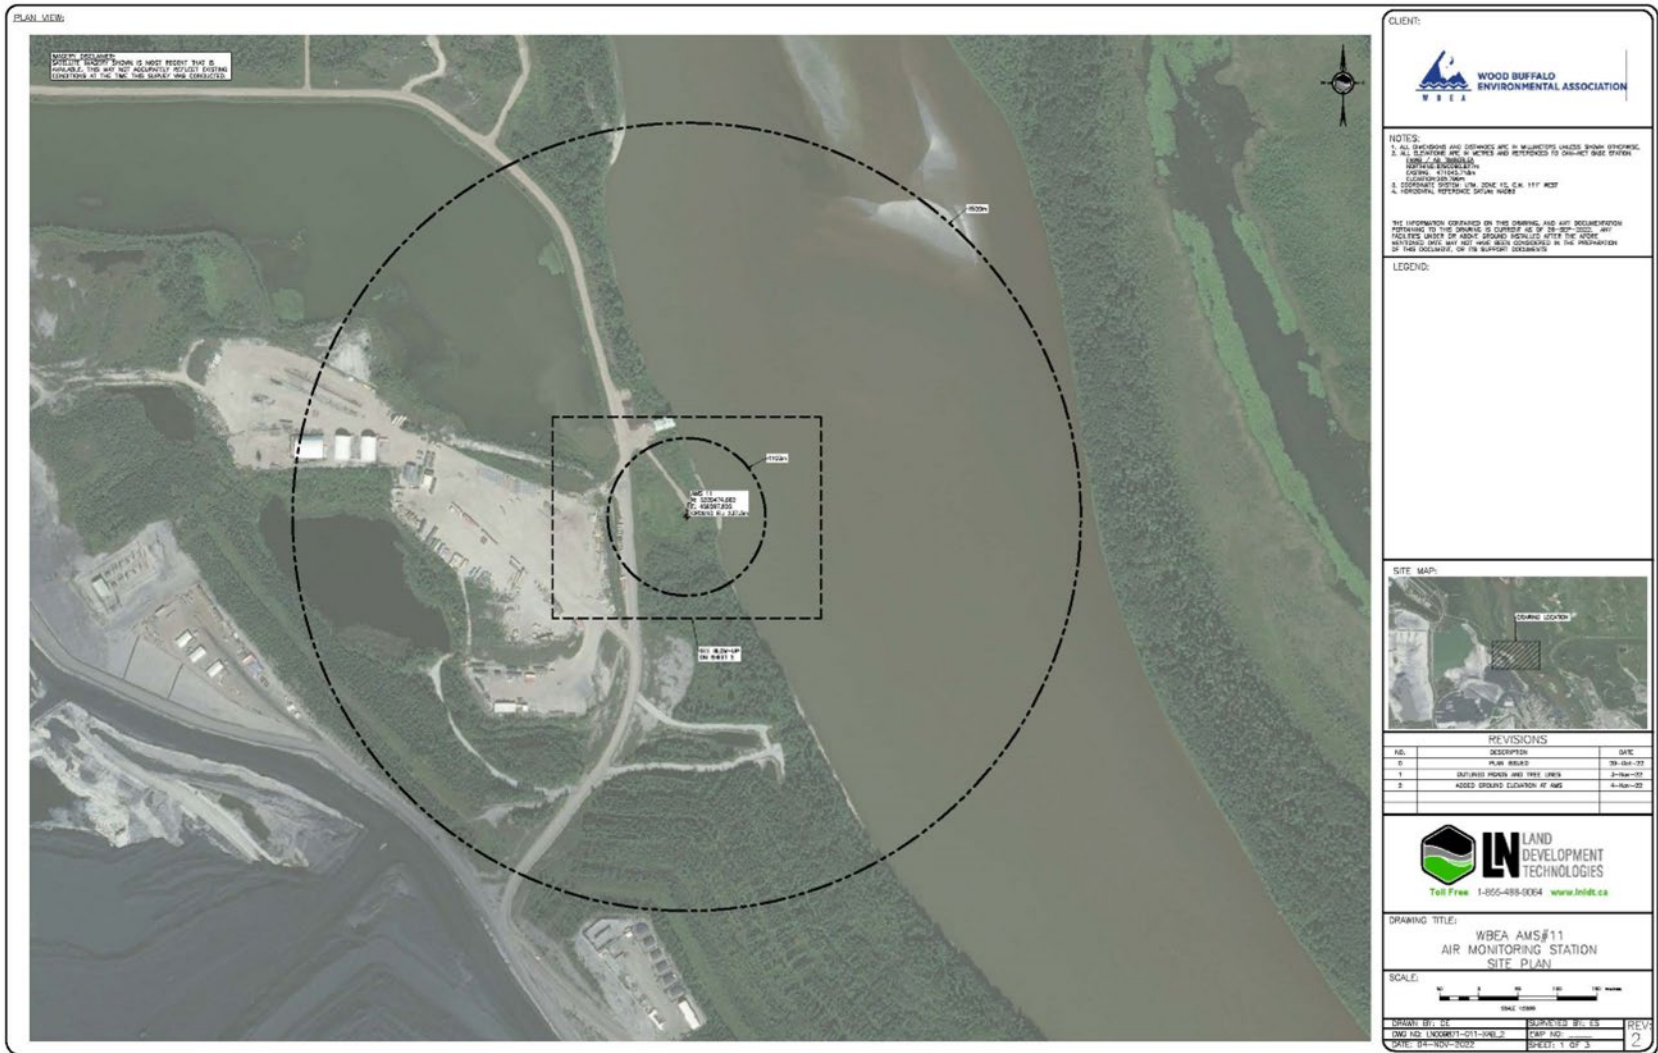
Figure 2 – Aerial image showing AMS 11.

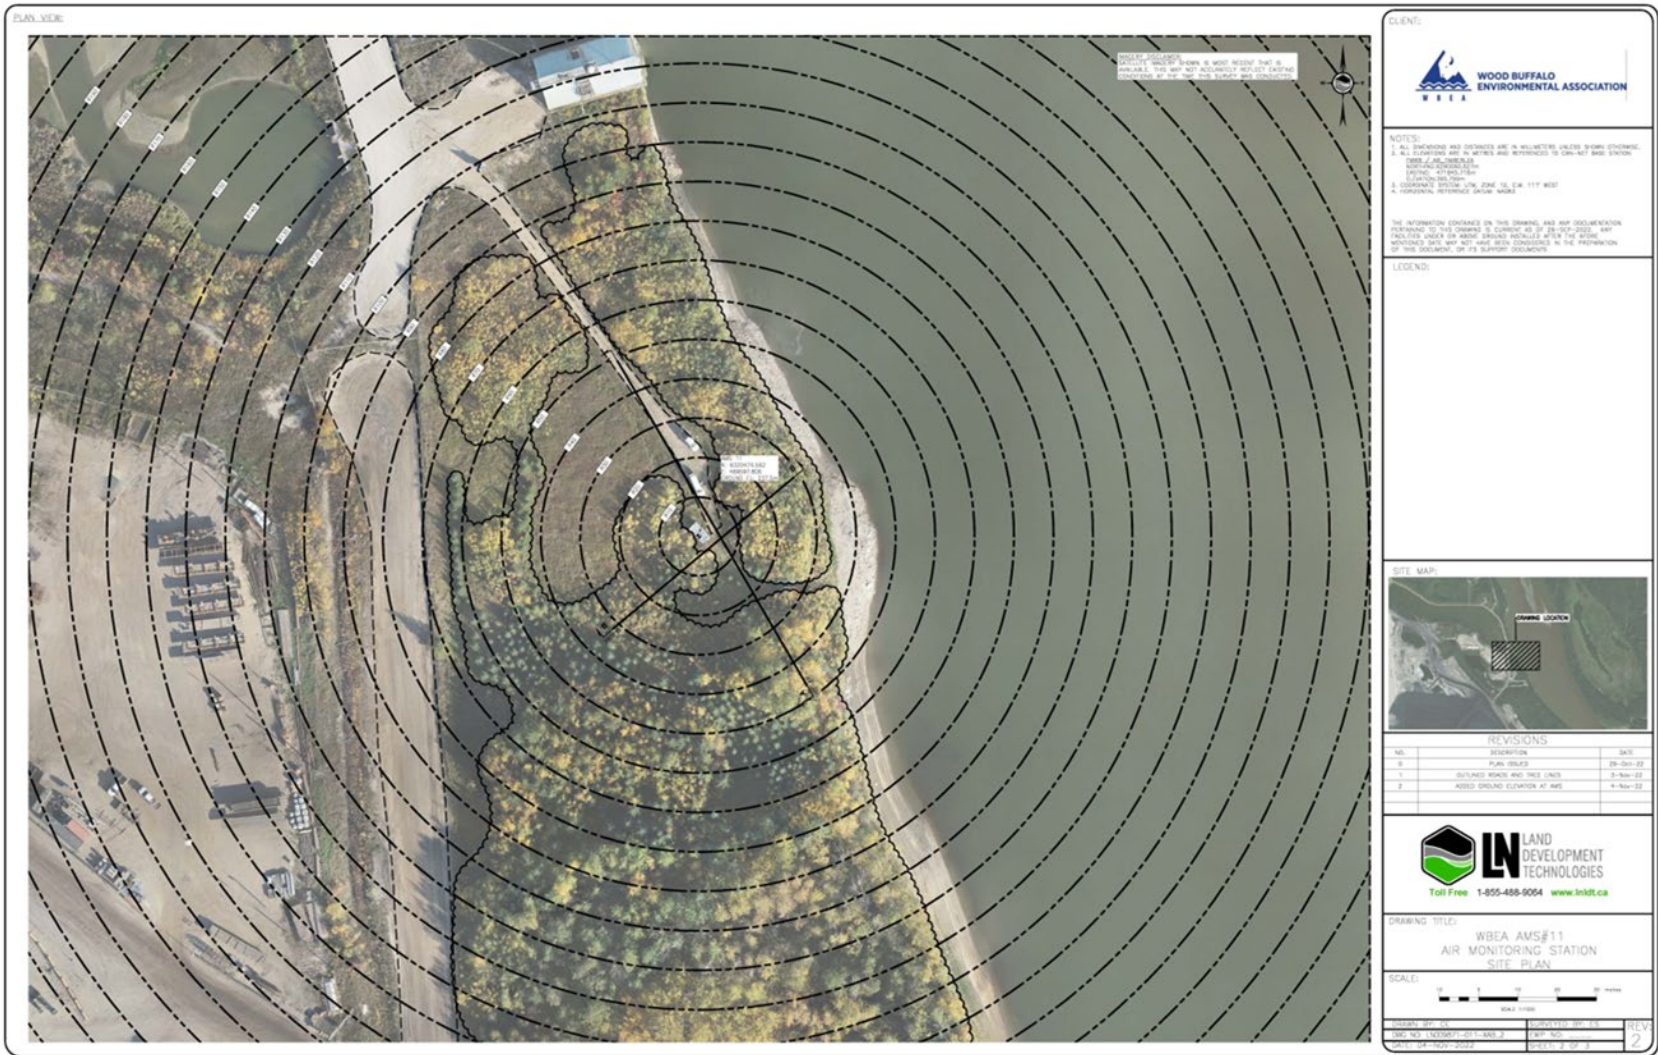
Figure 3 – Plan view image for AMS 11 site.

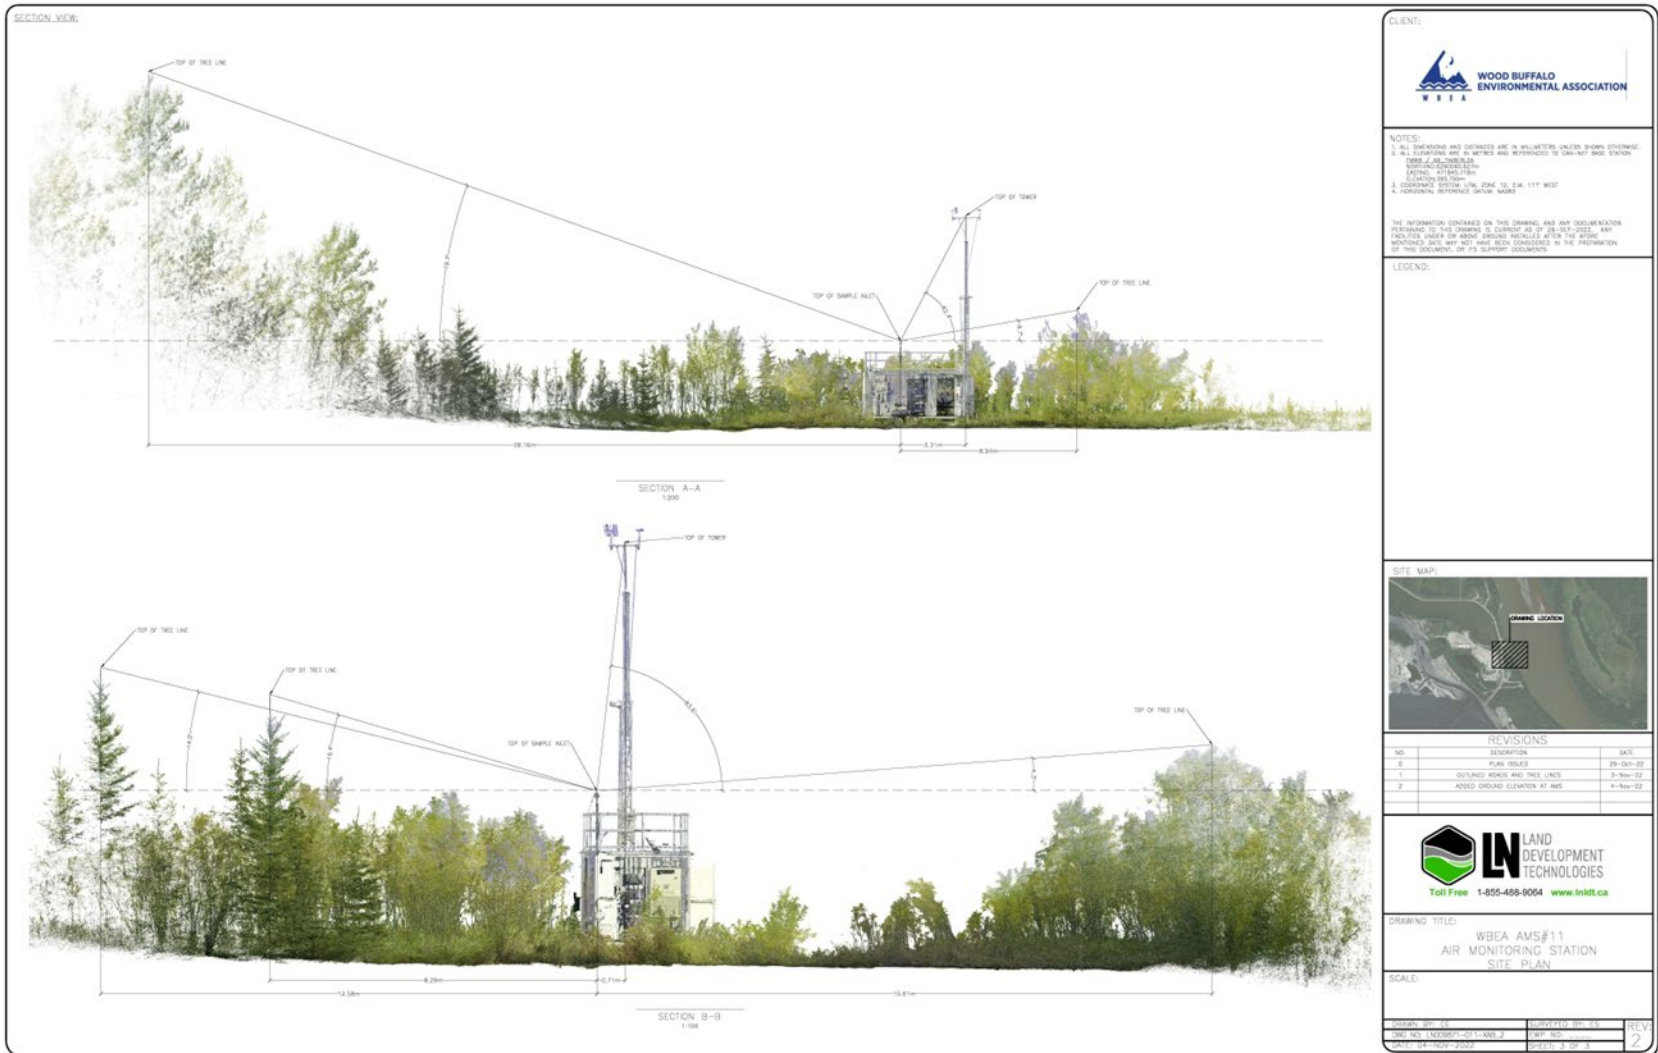
Figure 4 – Elevation view image for AMS 11 site.

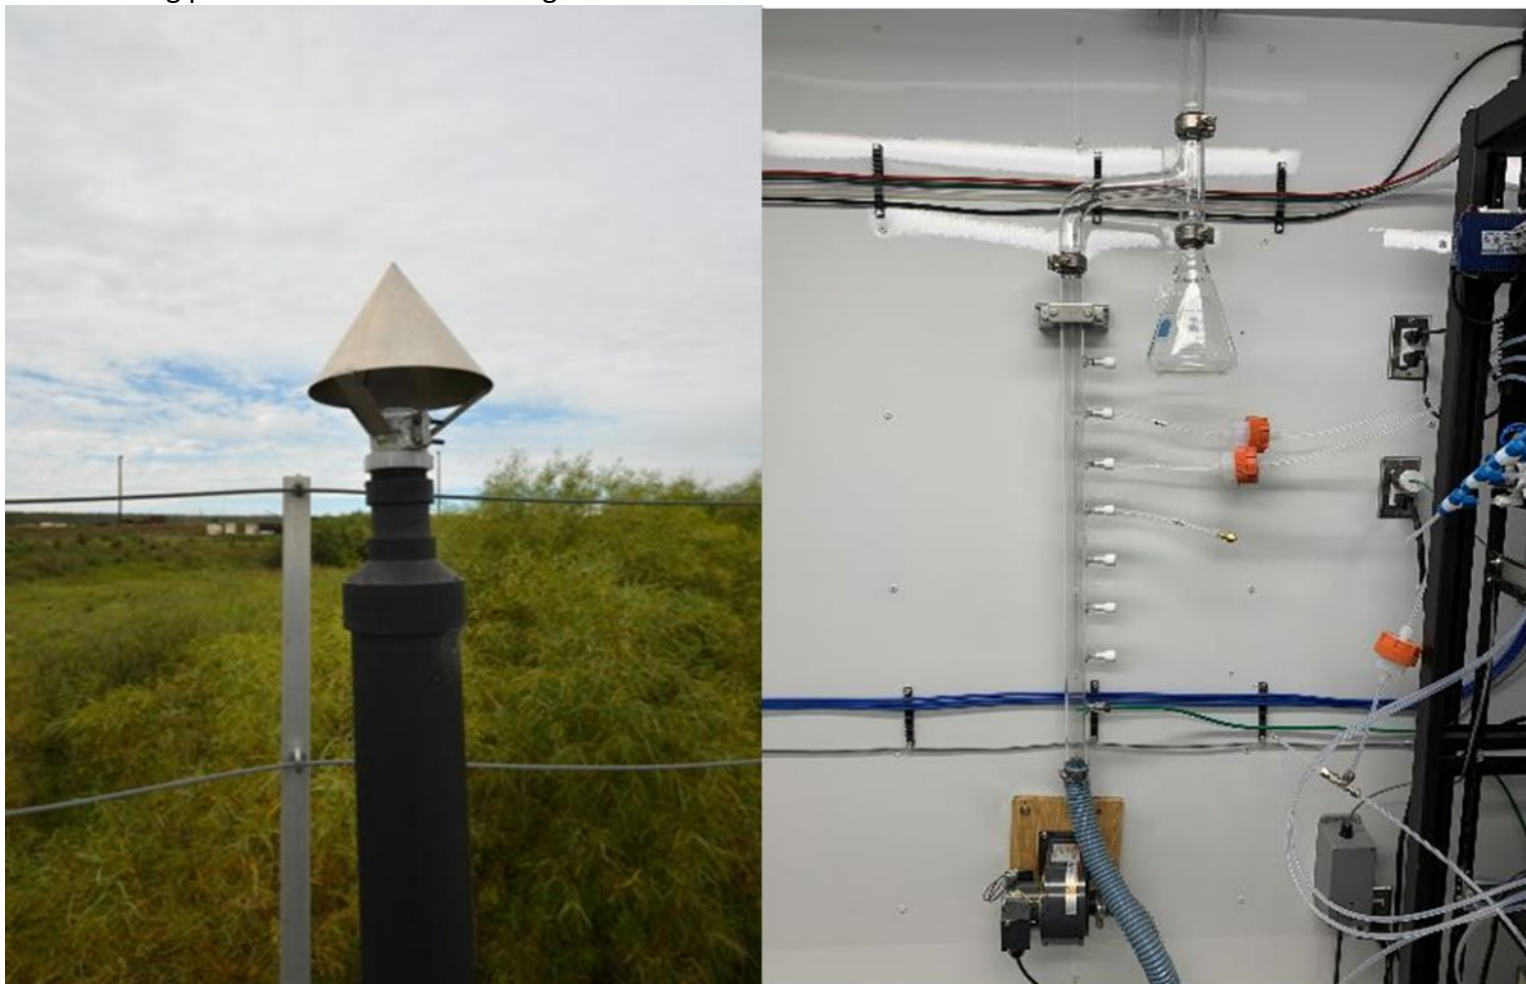
Figure 10 – Photo showing the inlet and sample manifold.

South	None
	West	None
Distance to nearest trees (m)	North	42
	East	12
	West	12
	South	NA
Sample manifold	Type	All glass
	Inlet height above roof	1 meter
Wind Sensors	Type	Cup and vane
	Height above ground (m)	10
	Distance from station (m)	attached

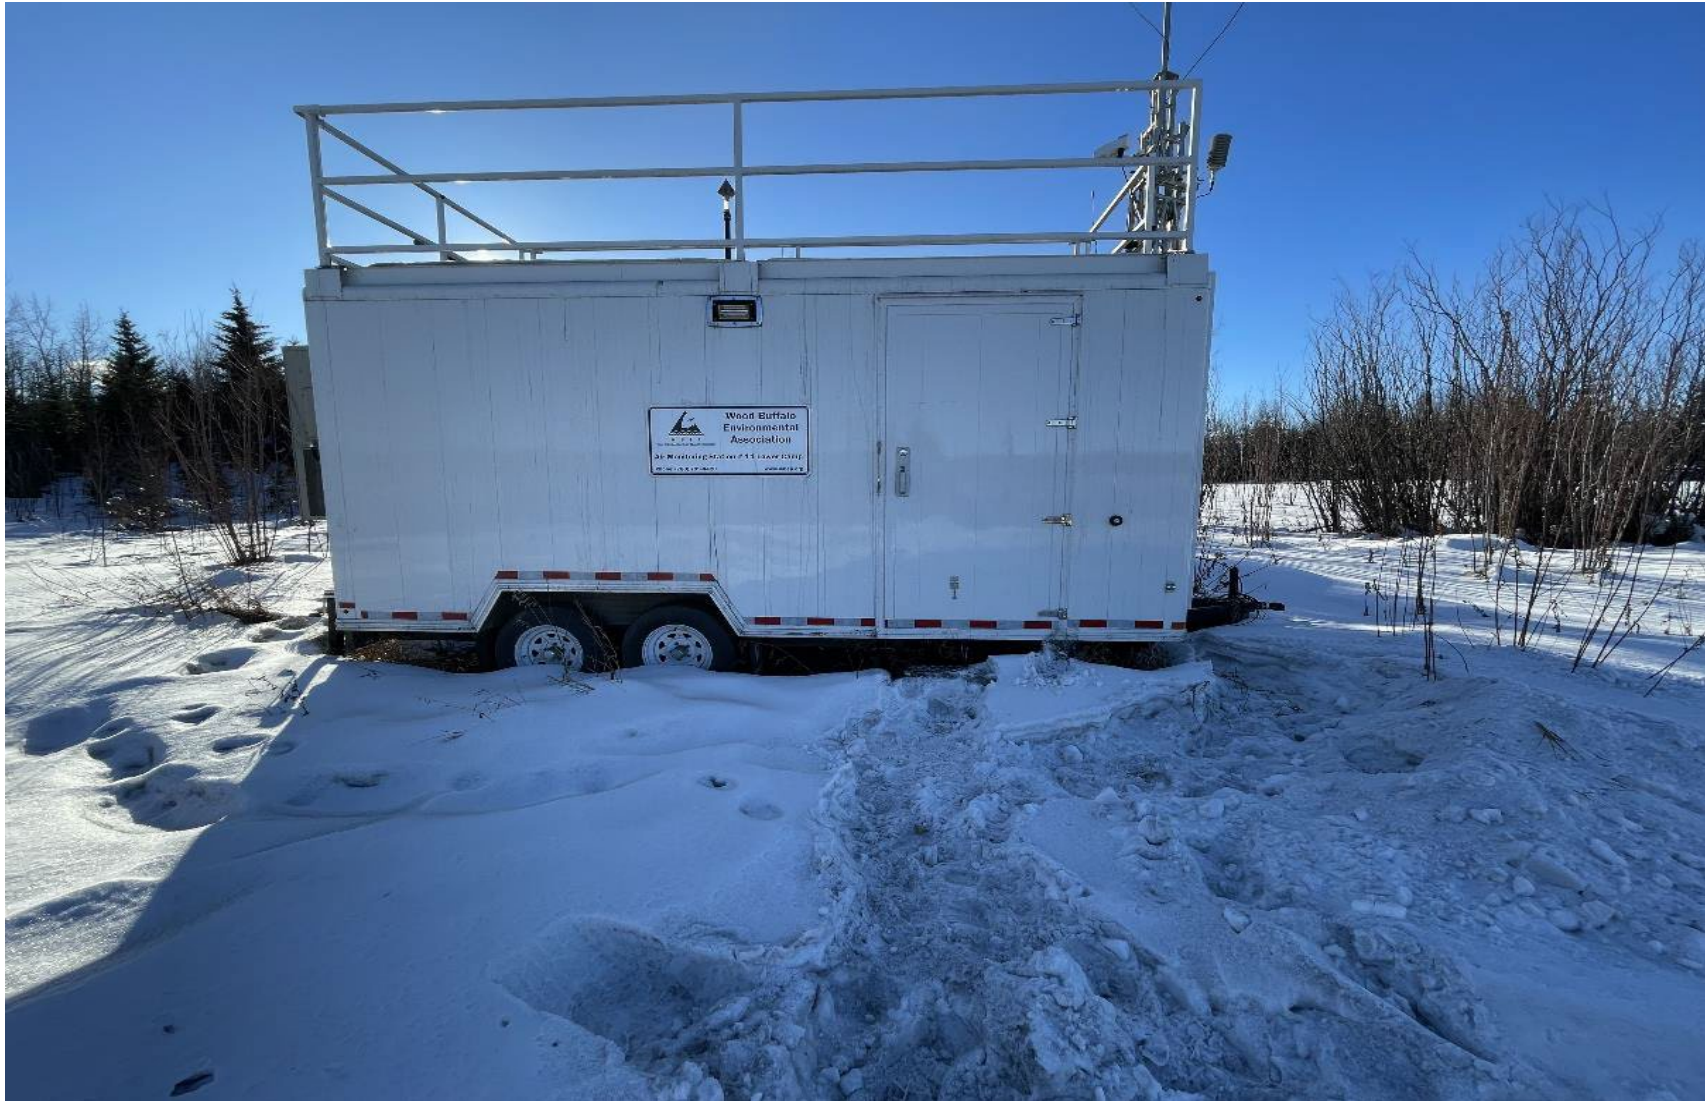
Figure 11 – Curb shot of the monitoring station.

Name	Description	Make	Model	Serial Number
Datalogger	Datalogger	Campbell Scientific	CR3000	2403
Gas Dilution Calibrator	Dynamic dilution calibrator	Teledyne/API	T700	3807
Zero air generator	Zero Air Generator	Teledyne/API	701	196
Shelter / Building	Air monitoring portable	ITB	8 x 16 trailer	11447

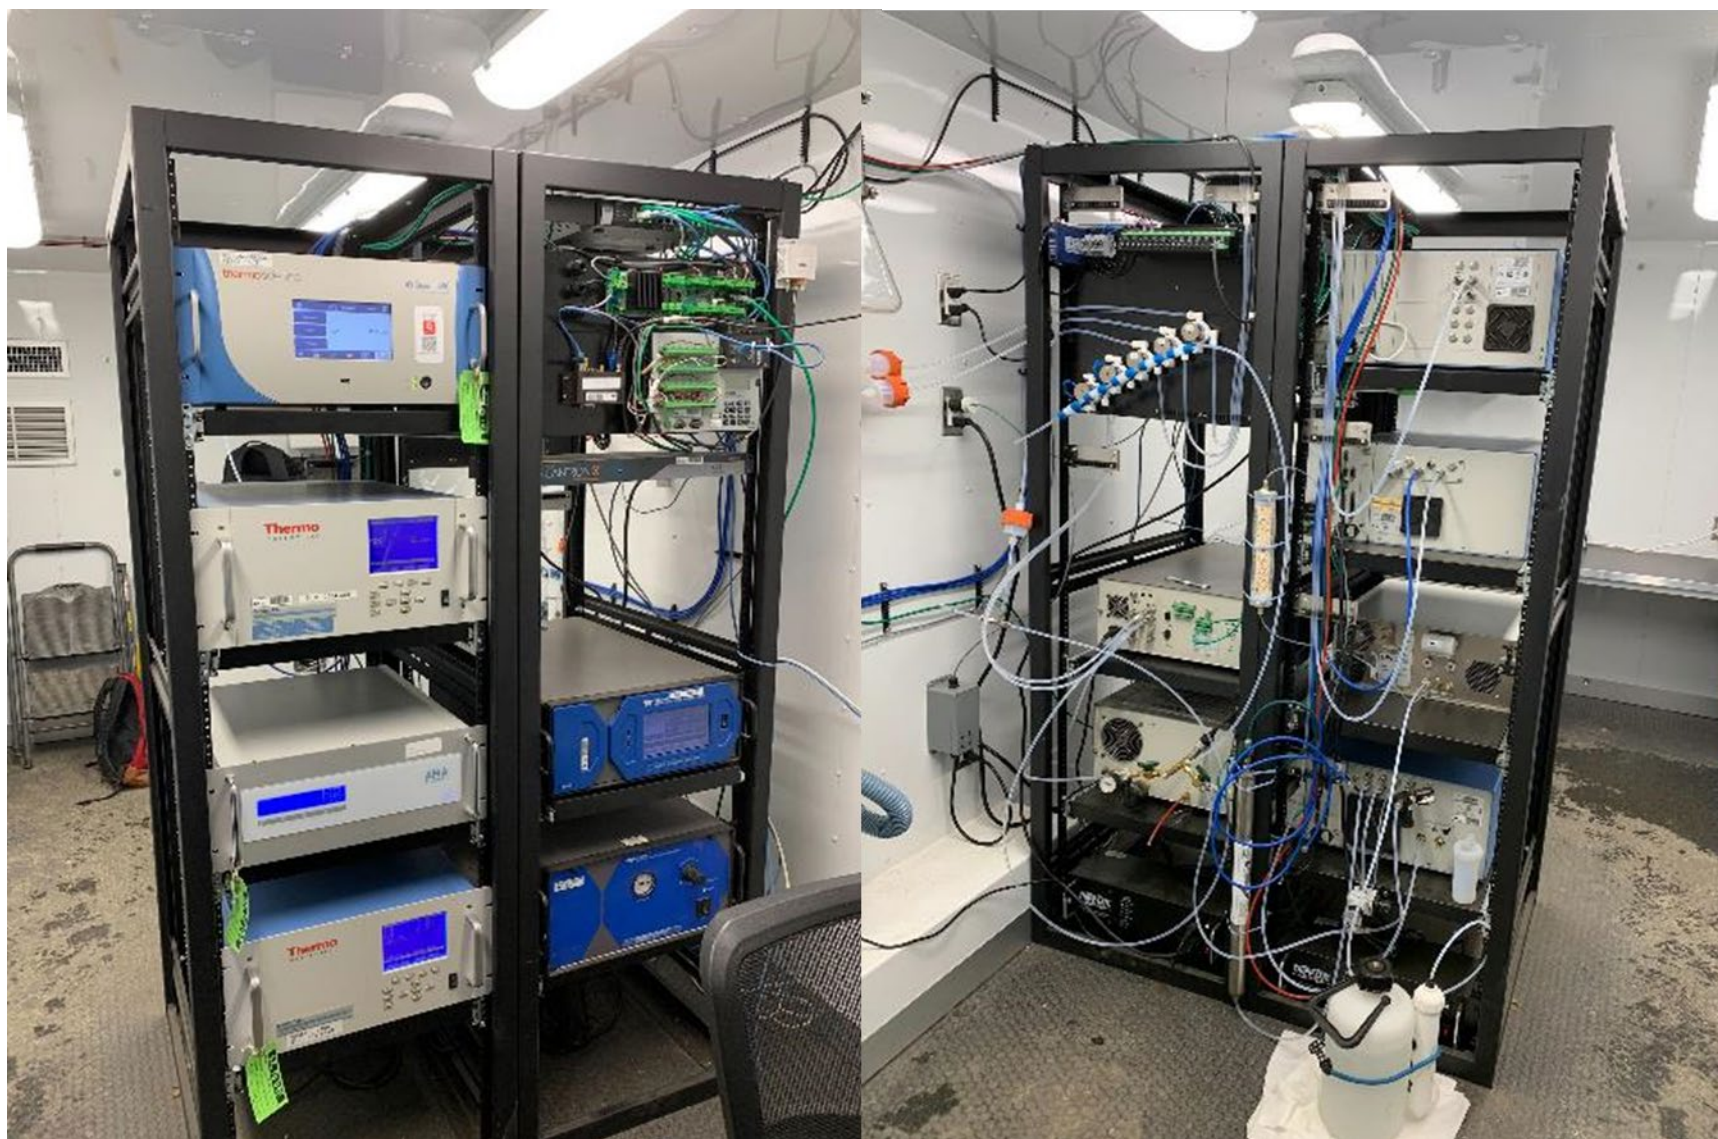
Figure 12 –Photo of the front and the back of instrument rack.

Parameter	Make	Model	Serial Number	Date Instrument Installed	WBEA Data Start Date
SO <sub>2</sub>	Thermo Scientific	43i	100841398	2015	January, 1999
H <sub>2</sub> S	Thermo Scientific	450iq	CM20080003	2015	January, 1999
THC/CH <sub>4</sub> /NMHC	Thermo Scientific	55i	1505164381	2019	January, 1999

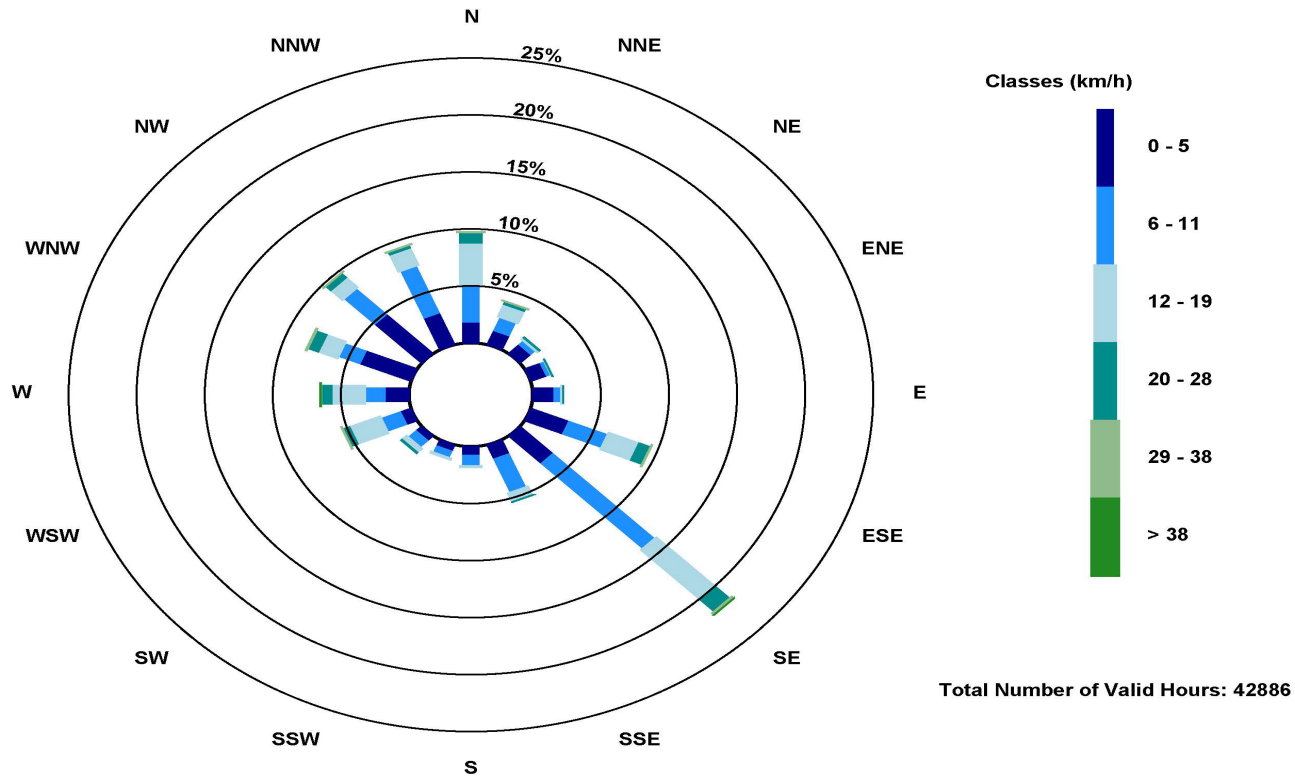
Wood Buffalo Environmental Association  
Wind Rose 2019 - 2024

Wind Speed (WS) - km/h  
Lower Camp

Figure 13 – Windrose (five year)
