Wood Buffalo Environmental Association
Ambient Air Monitoring Station
Site Documentation

Christina Lake

LAST UPDATED: MARCH 28, 2024

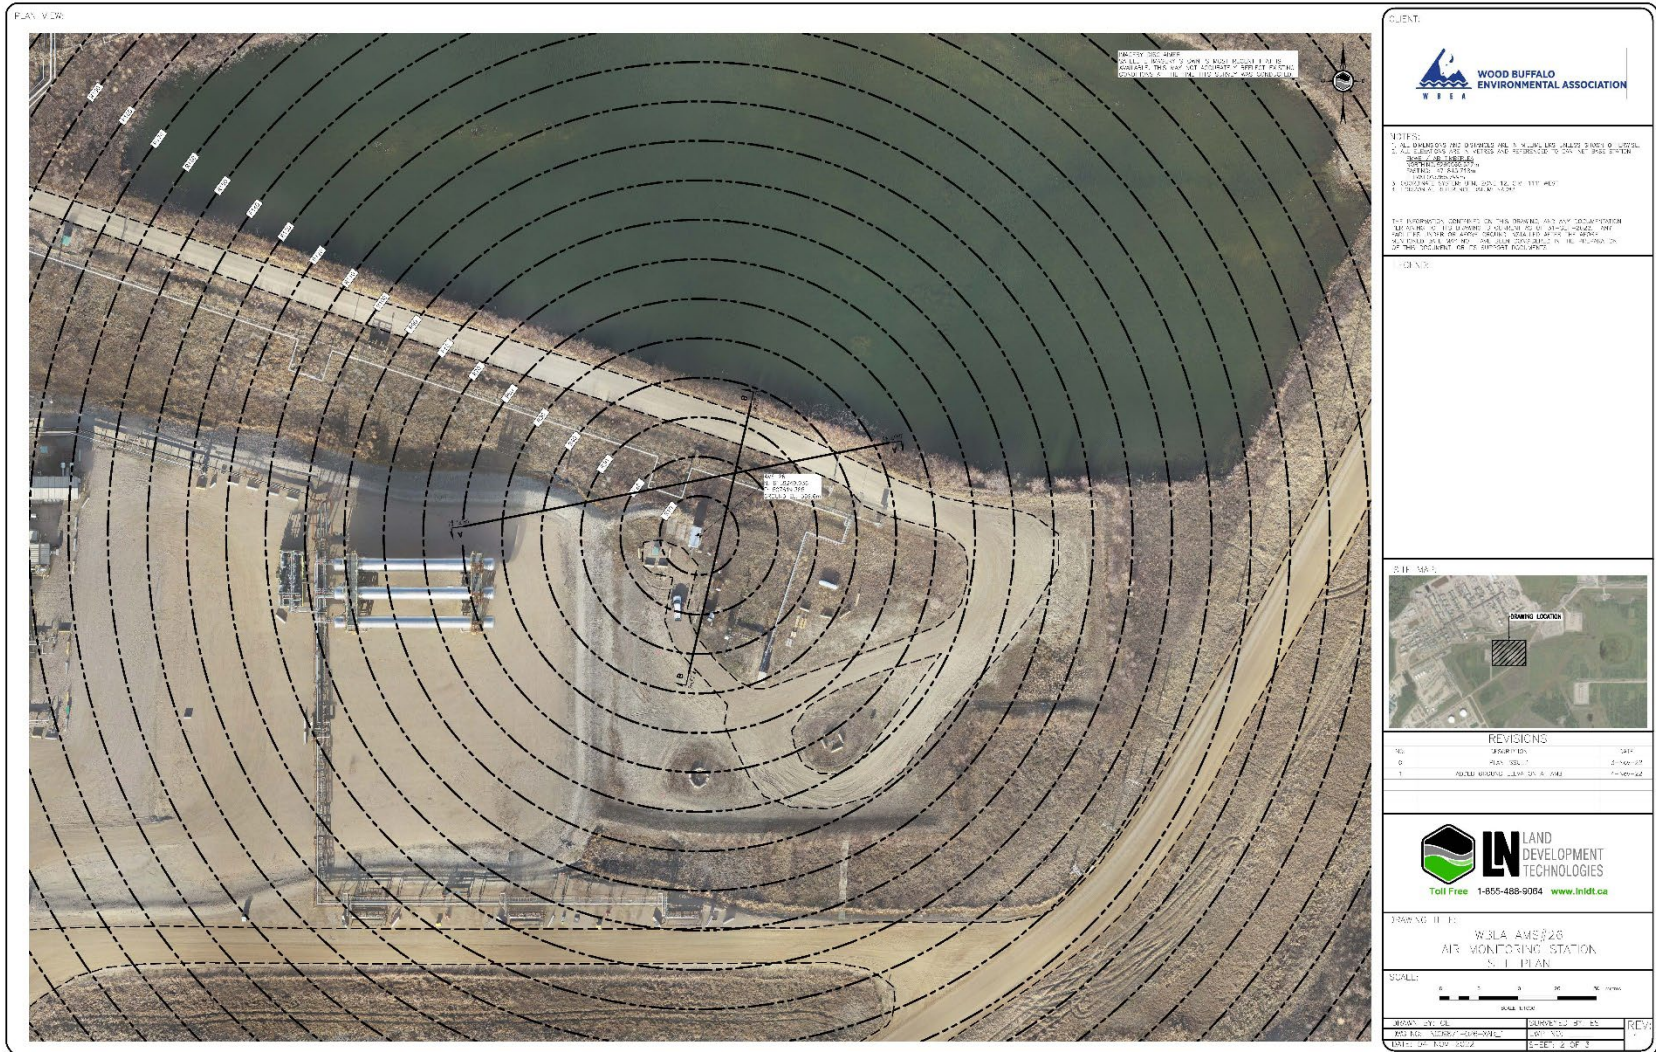
Figure 2 – Plan view image for AMS 26 site.

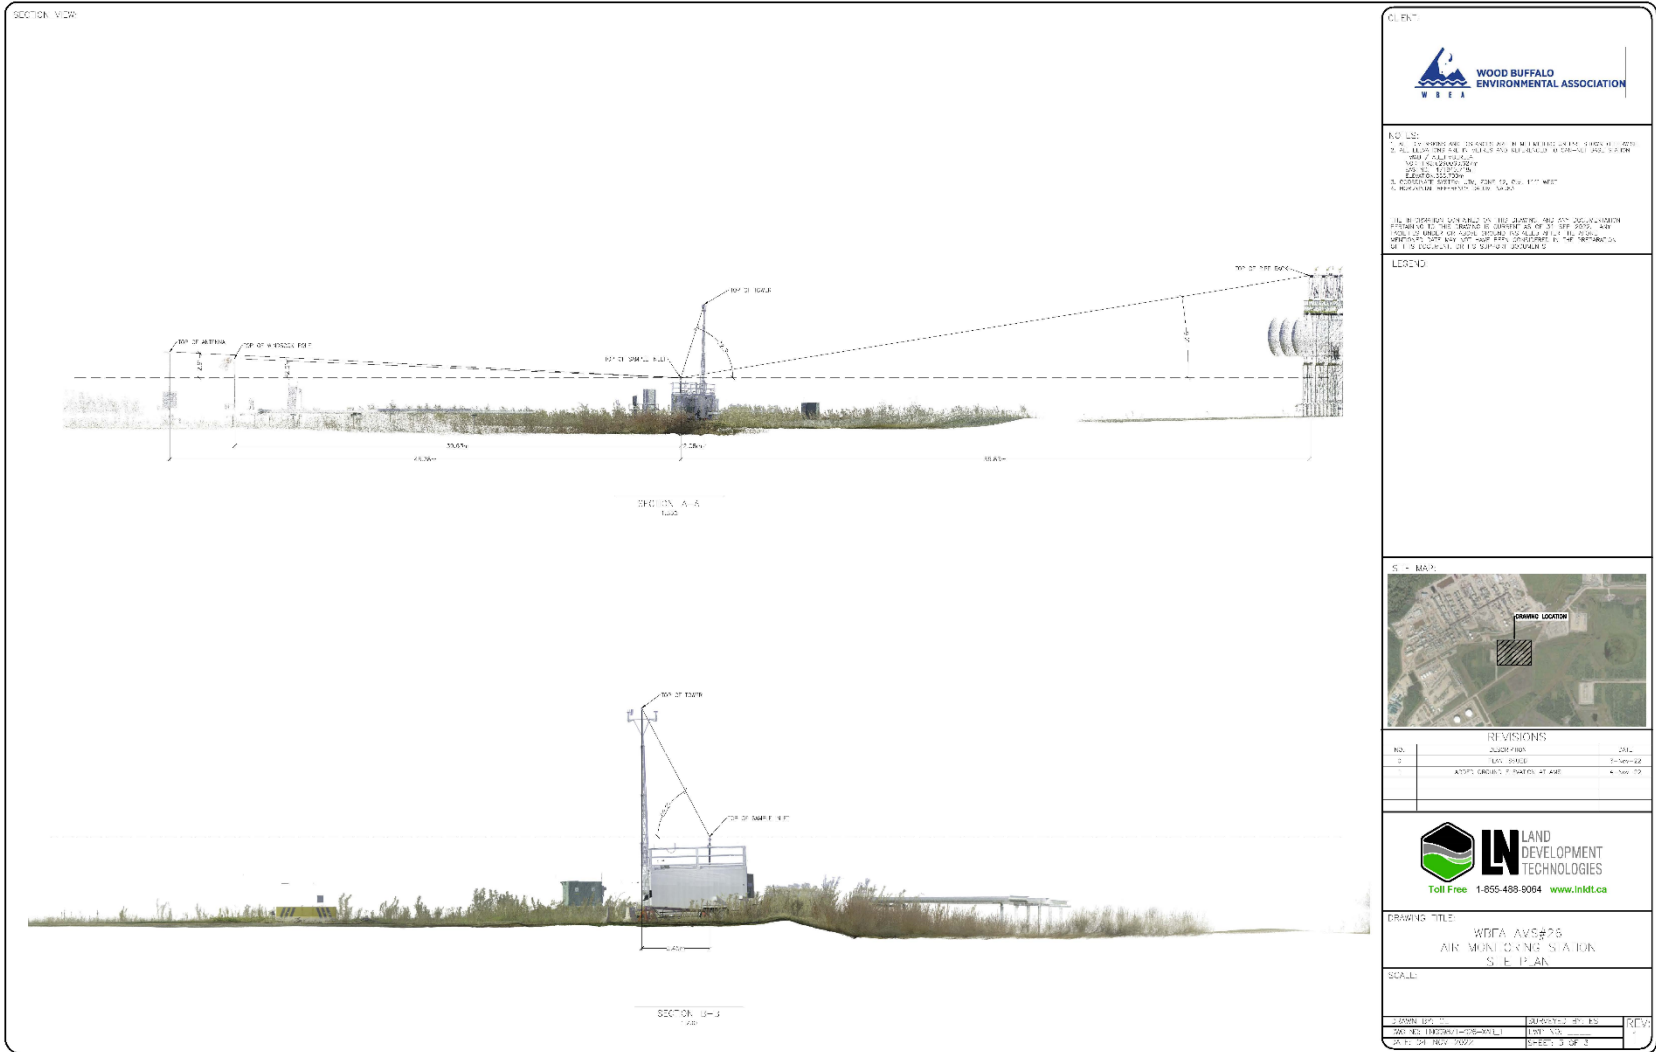
Figure 4 – Elevation view image for AMS 26.

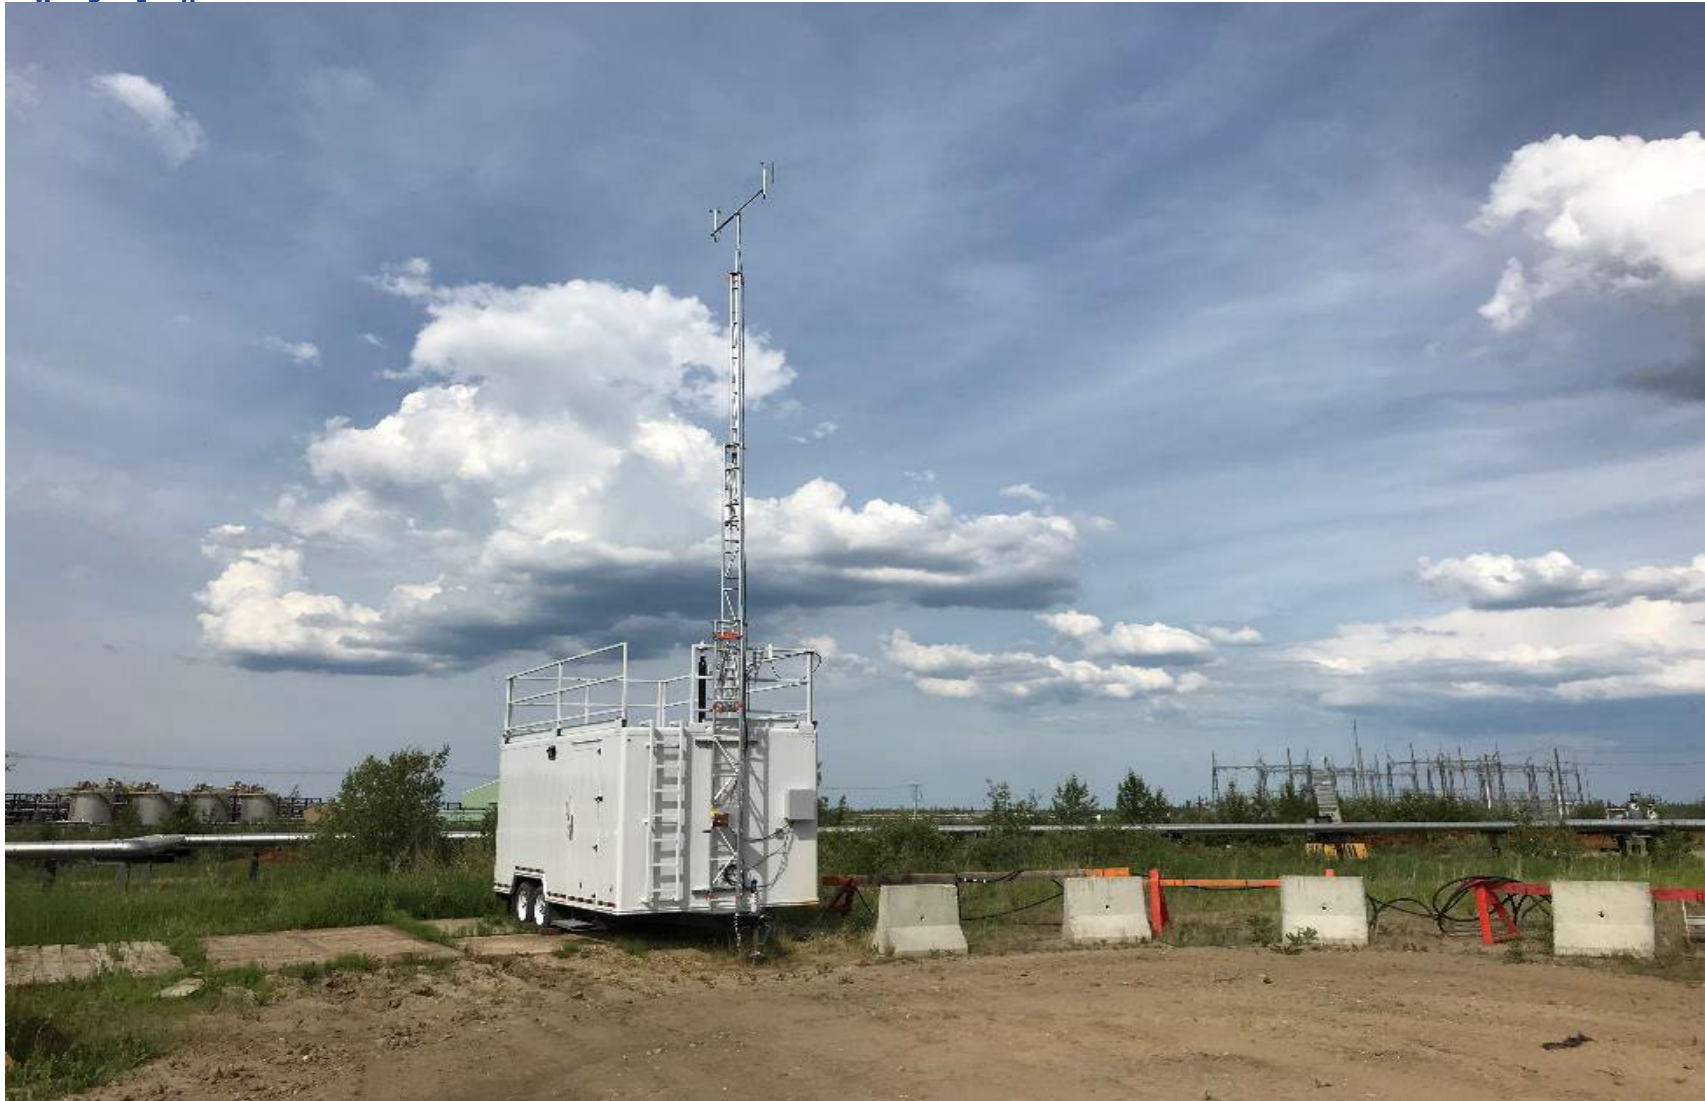
Figure 9 – Meteorological tower.

Parameter	Make	Model	Serial Number	WMO Site Class	Date Installed	WBEA Data Start Date
AT/RH	Vaisala	HMP155	G4330034	4	May 30, 2018	June, 2018
WS	Met One	010C-1	W23536	2	May 30, 2018	June, 2018
WD	Met One	020C-1	W23733	2	May 30, 2018	June, 2018

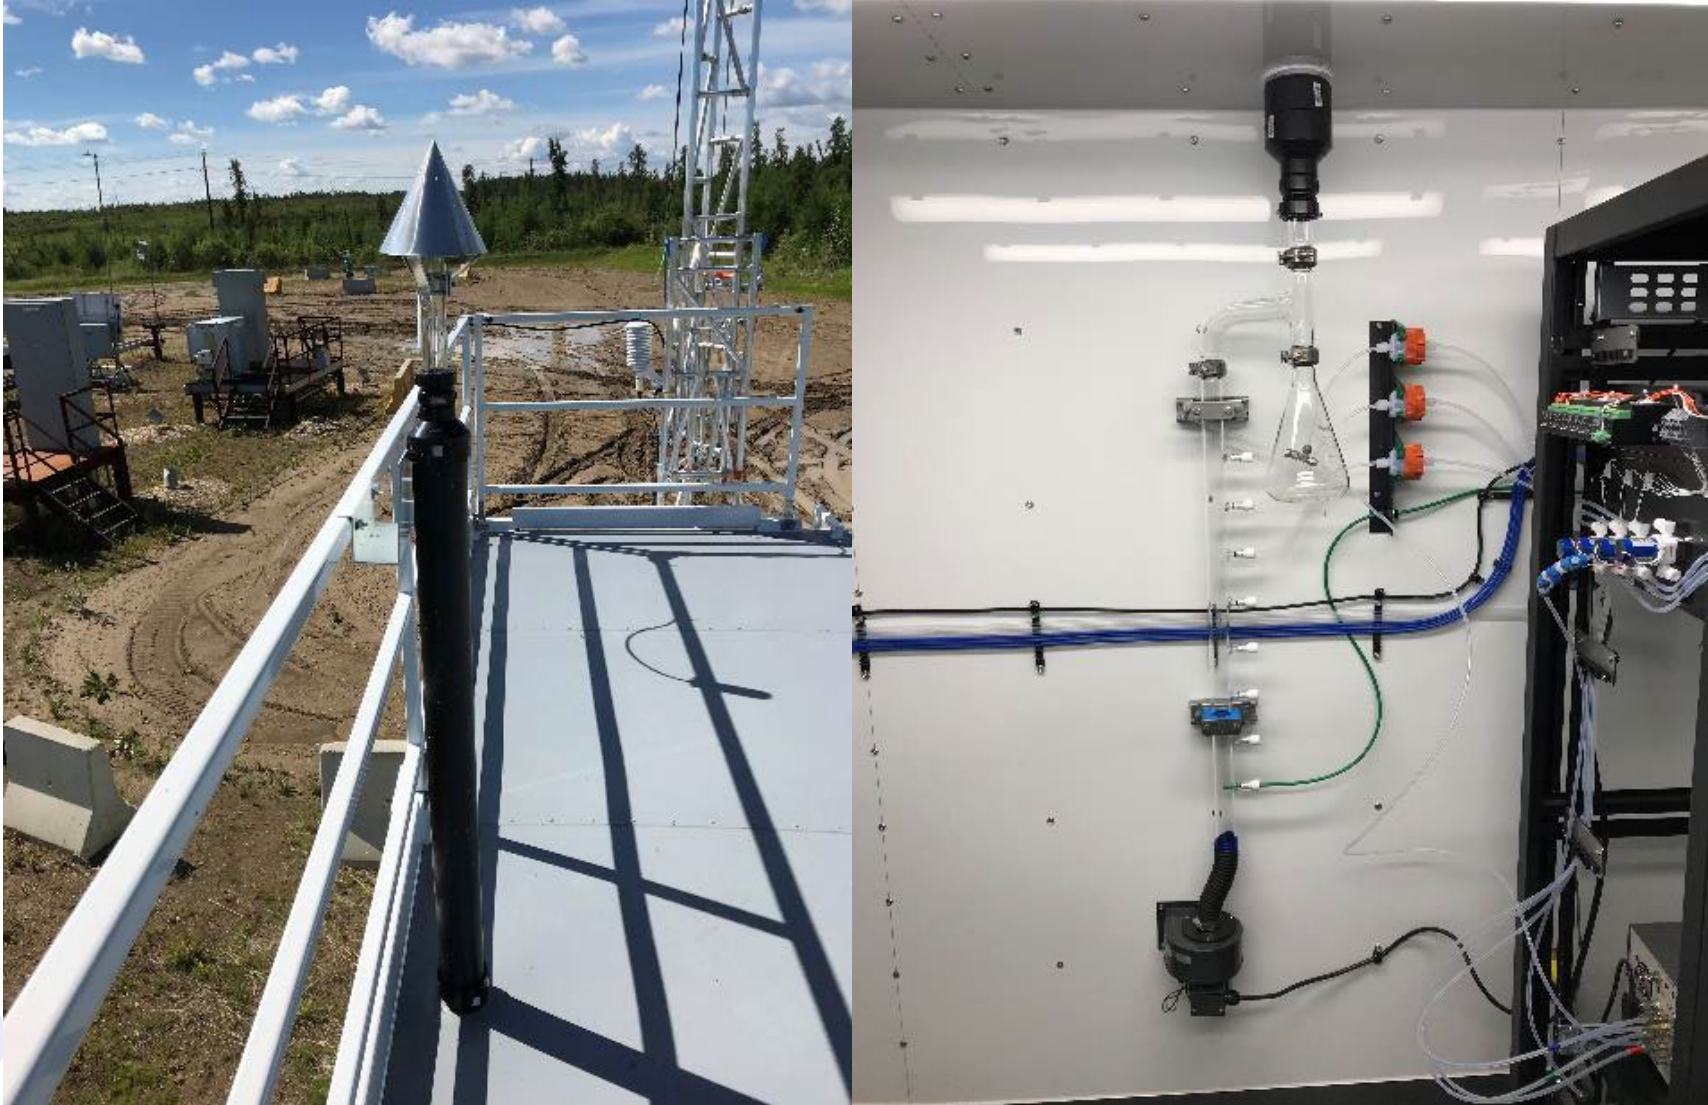
Figure 10 – Photo showing the inlet and sample manifold.

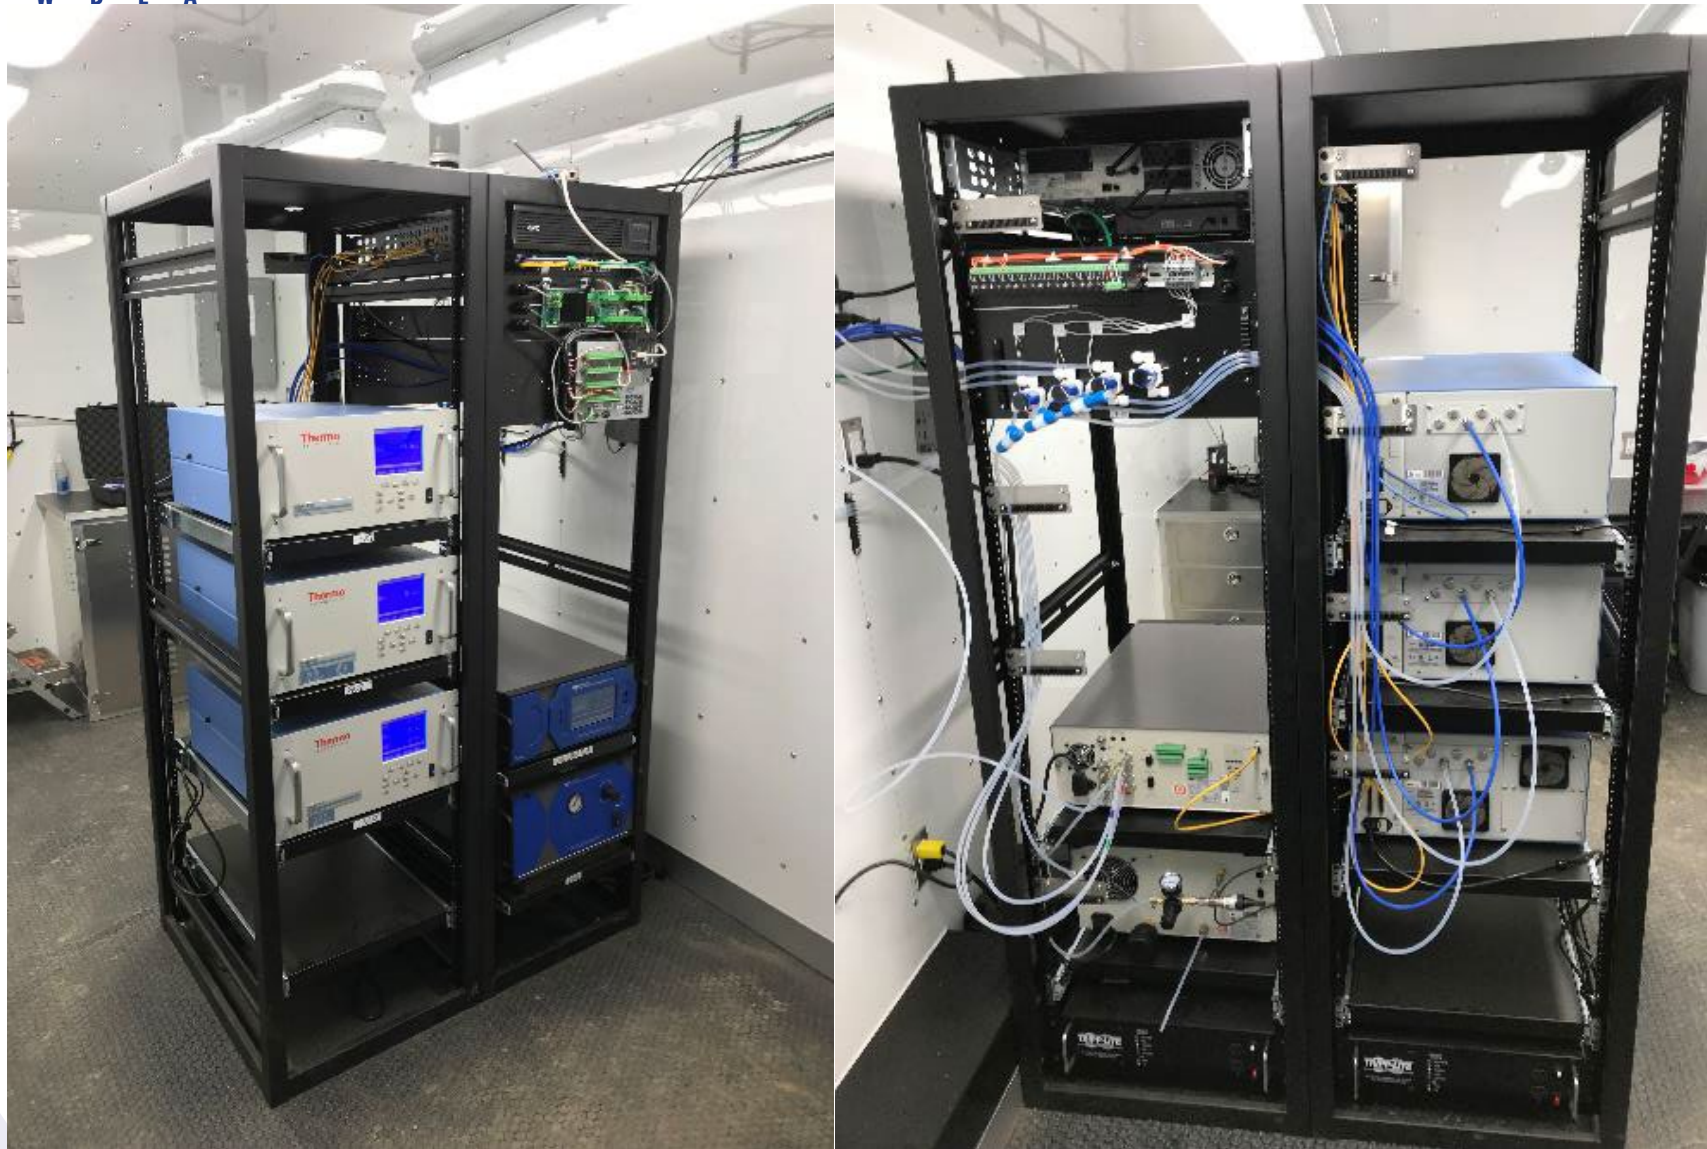
Figure 12 –Photo of front and back of instrument rack.

Parameter	Owner	Make	Model	Serial Number	Date Instrument Installed	WBEA Data Start Date
SO ₂	Cenovus	Thermo Instruments	43I	1152430005	February, 2024	June, 2018
H ₂ S	Cenovus	Thermo Instruments	450I	1180030032	May, 2018	June, 2018
NO/NO _x /NO ₂	Cenovus	Thermo Instruments	42I	1173480006	May, 2018	June, 2018

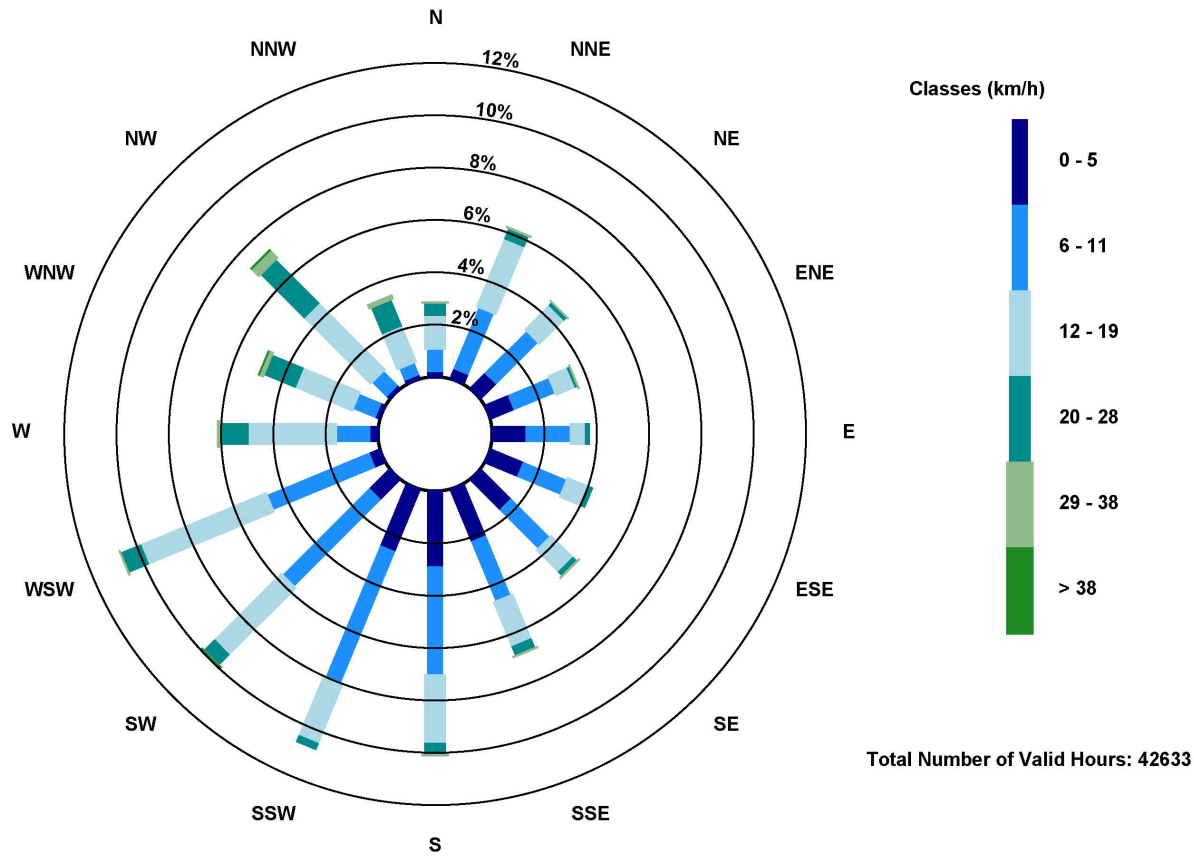
Wood Buffalo Environmental Association
Wind Rose 2019 - 2024

Wind Speed (WS) - km/h
Christina Lake

Figure 13 – Windrose (Five Year).
